INDOOR AIR QUALITY REASSESSMENT

**Winthrop Elementary School
162 First Street
Melrose, Massachusetts**

Prepared by:
Massachusetts Department of Public Health
Bureau of Environmental Health Assessment
June, 2002

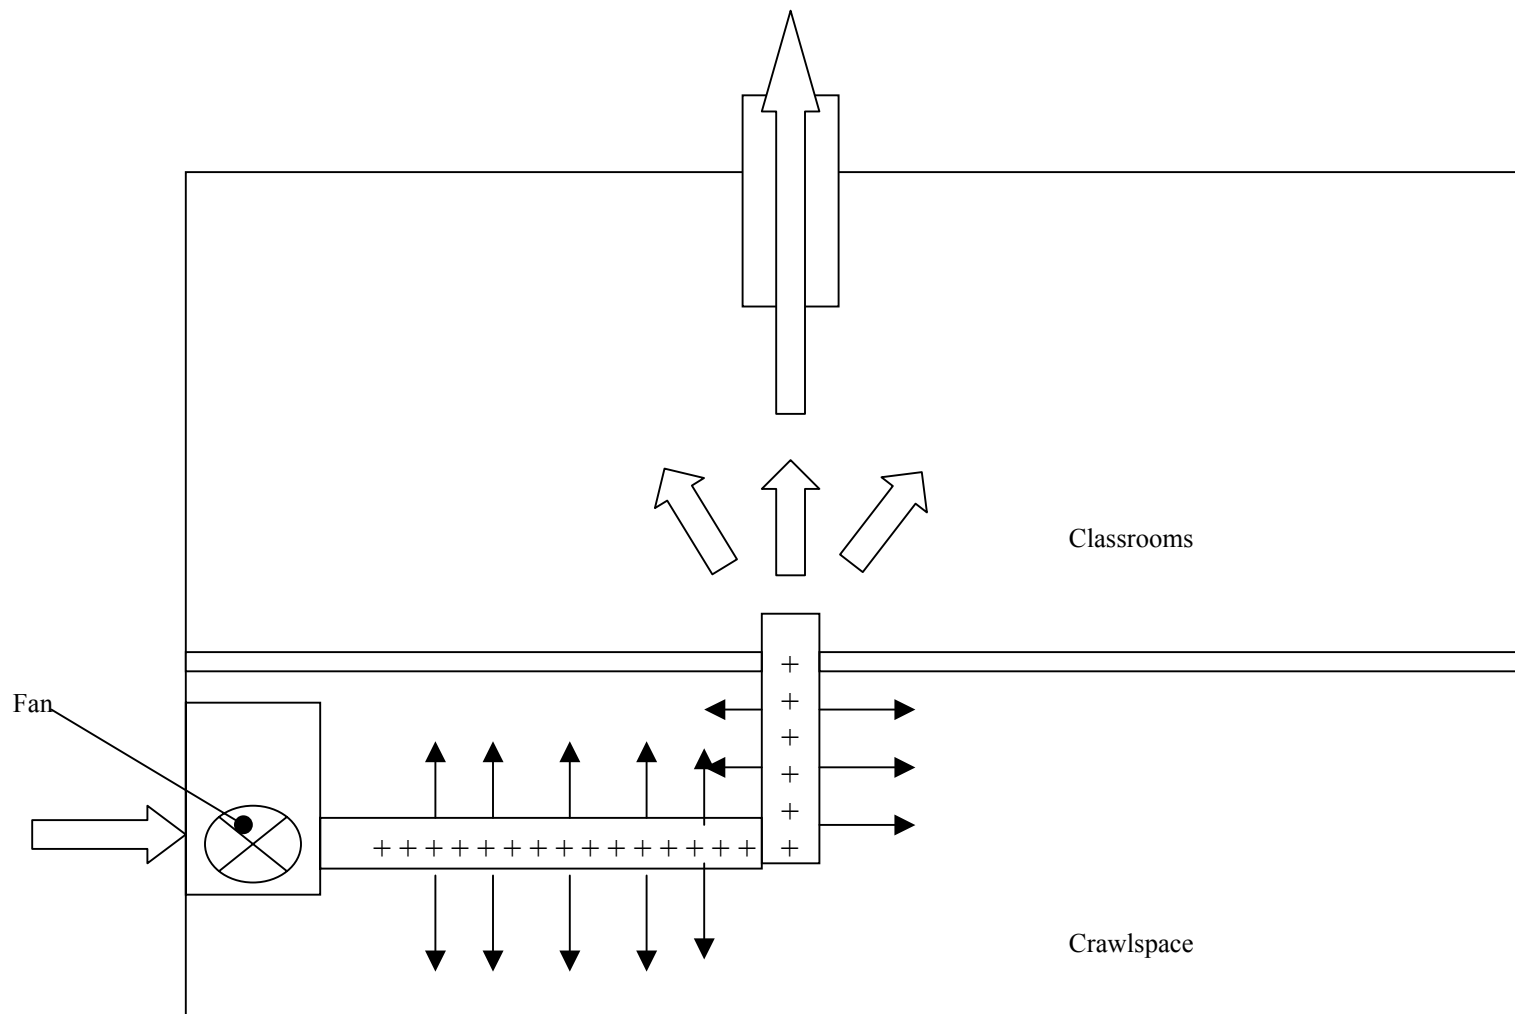
Figure 2
Original Design of Mechanical Ventilation System that would Inject Outdoor Air into Ducts, Creating Positive Pressure

The function of the 1926 building ventilation system was altered by the repairs and renovations listed in the **Appendix I** of this report. The original design was intended to pressurize the building by forcing fresh air into the building through supply ductwork. This would force air from the building by pressurization. Heated air would rise and exit the building through louvers within rooftop air ducts. The installation of exhaust vent motors on the rooftop (see Picture 1) and use of the original sash window vent in the basement has reversed the air pressure relationship to *depressurize* the ductwork. The depressurization of the building can have the negative effect of drawing materials through spaces in walls, floors and ductwork.

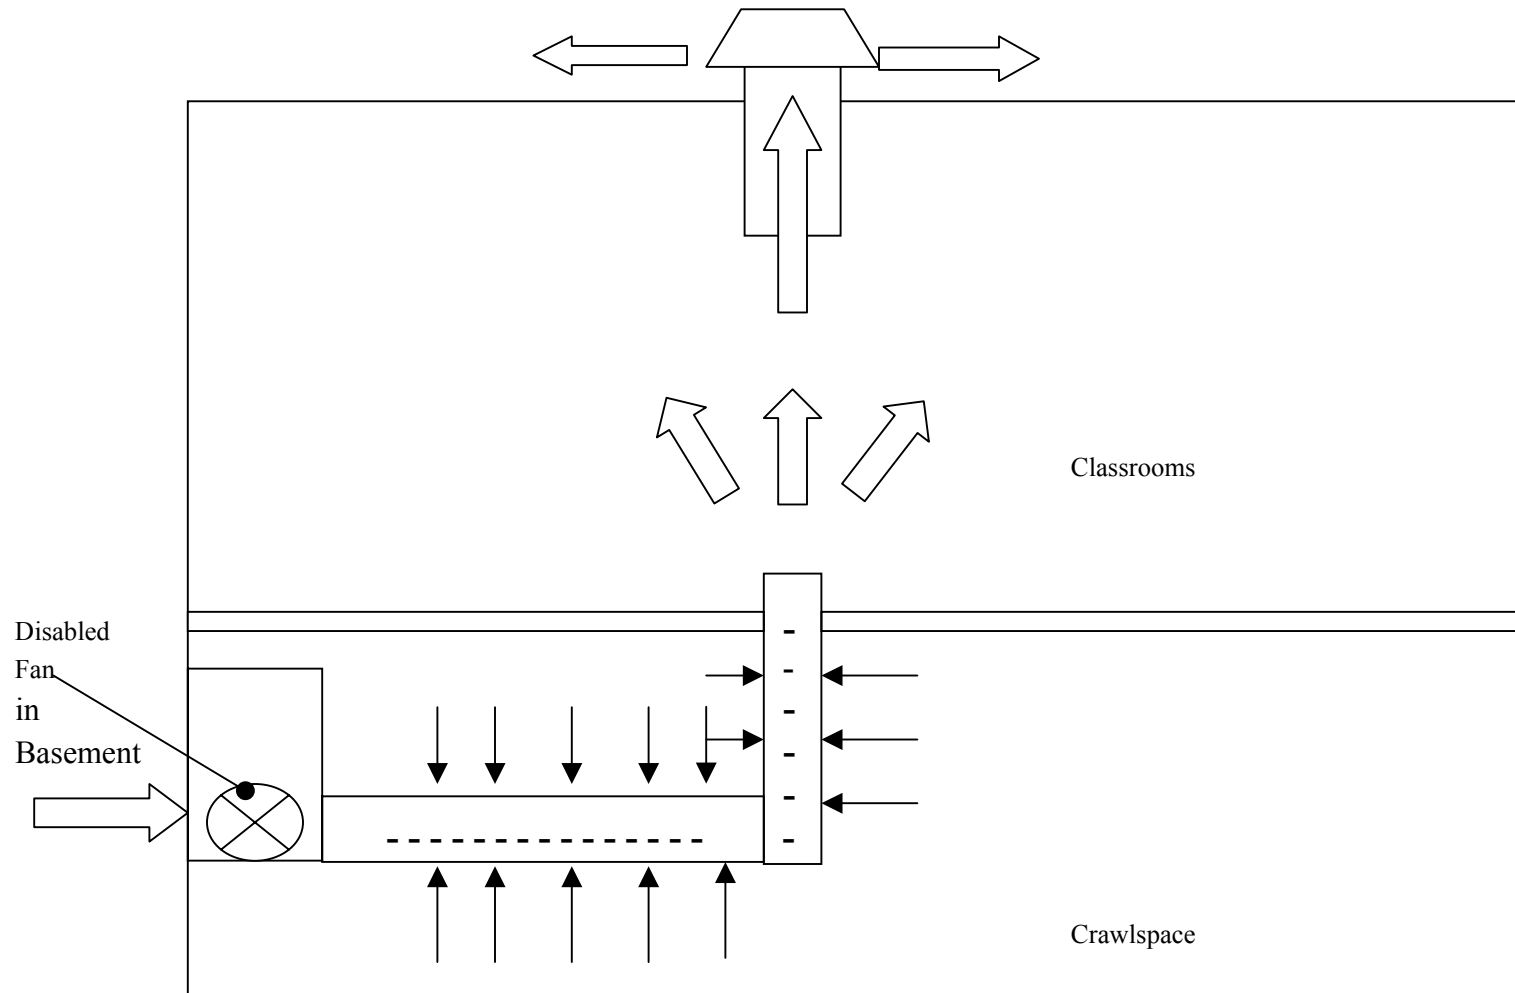
Figure 3
Redesign of Mechanical Ventilation System: Installation of Rooftop Mechanical Exhaust Fans Draw Air into Ducts Creating Negative Pressure, Which in Turn Draws Crawlspace Air into Ducts through Seams

dust became aerosolized as BEHA staff entered the crawlspace. In general, ventilation ductwork is not always airtight. Seams between the metal sheets of ductwork can allow air to pass into or from the duct. Since the original ductwork is damaged, rendering all seams airtight would be difficult. As originally designed, the basement fan injects outdoor air into ductwork forcing air into classrooms by creating positive pressure (Figure 2). By forcing air into the ductwork, air is forced through existing spaces in the sheet metal and into the crawlspace. The original design prevents the draw of crawlspace dust and other pollutants into ductwork. The new installation (see Figure 3) draws air from the outdoors through the original fresh air vent. This installation creates negative pressure in ducts, which tends to draw air into ducts, and in turn, may be distributed into some classrooms.

The installation of the new mechanical exhaust system is one large step needed to be taken to establish a functioning ventilation system in the building. Steps taken in response to the previous BEHA assessment would serve to improve indoor air quality in the Winthrop Elementary School. Restoration of the fresh air intake fan is necessary to pressurize the supply ductwork to prevent draw of crawlspace air. Restoration of the basement fresh air supply fan to an operation speed that would only pressurize vents would serve to eliminate crawlspace air draw into the ductwork.

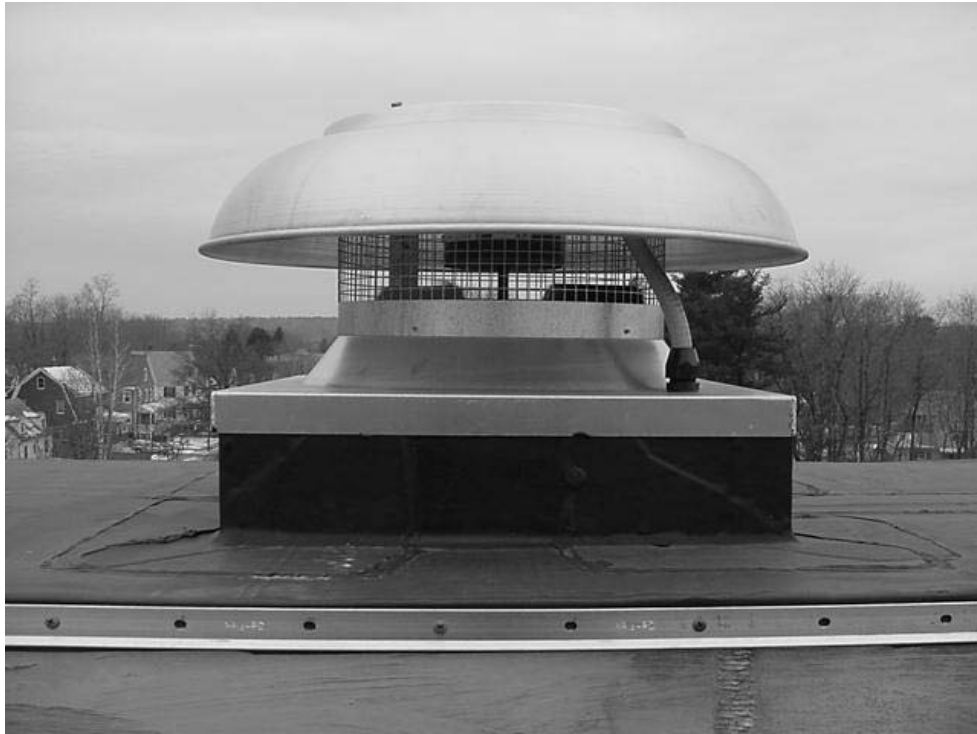
Picture 1

A Motorized Exhaust Fan Installed on the Roof

16.1. Motorized exhaust vents were installed on the roof (see Picture 1).
